ProEnergis
Chartered Surveyors

DATE OF INSPECTION: 18 November 2010

BUILDING SURVEY REPORT

Example building survey

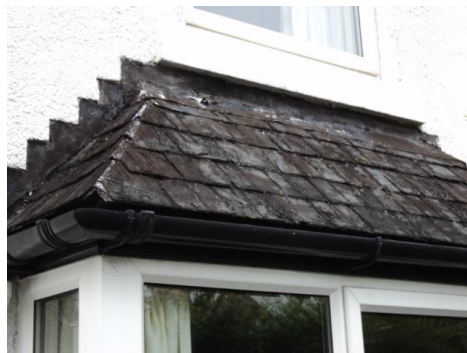
The bay roof is in slate which appears to have been overpainted with a waterproofing type compound. This is usually applied to prolong the life of and repair a leaking slate roof. However, there is no evidence of internal leakage or external defect to lead us to suspect that any defect exists.

Bay roof

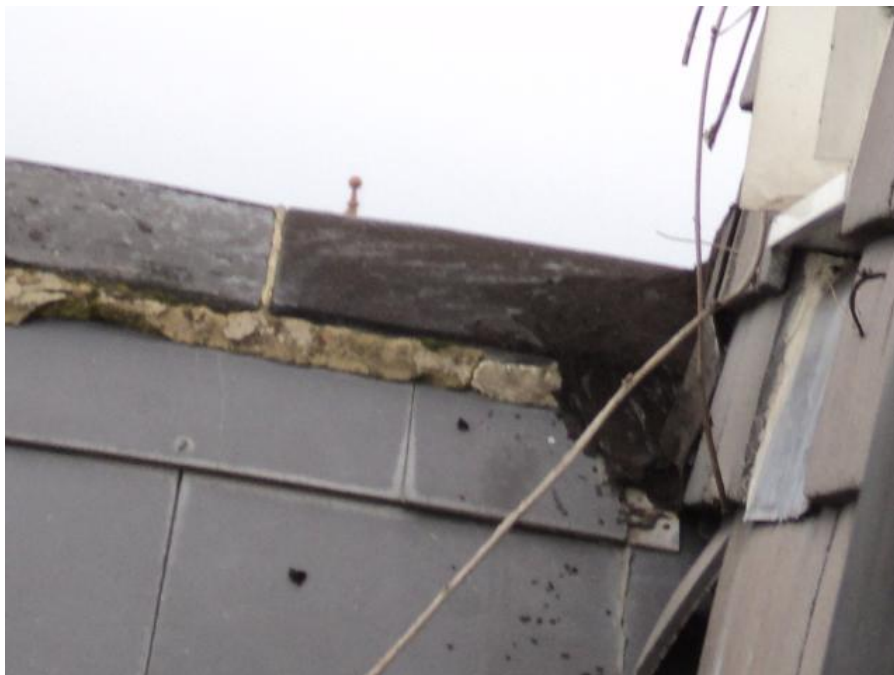
We noted some tar/bitumen compound had been applied to the rear ridge to the side of the dormer roof. This is thought likely to be to repair a former leak. There is no evidence of internal leakage, however this is not likely to provide a permanent solution to a problem and we recommend that a roofing contractor is instructed to undertake a precautionary inspection of this area.

Repair to rear ridge

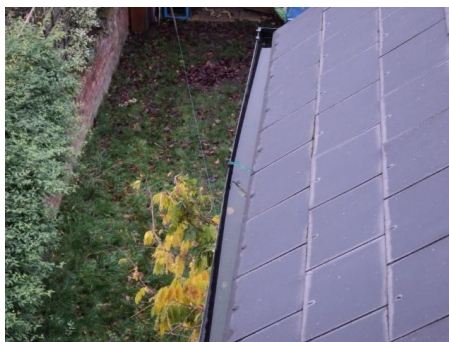
Misaligned gutter to rear

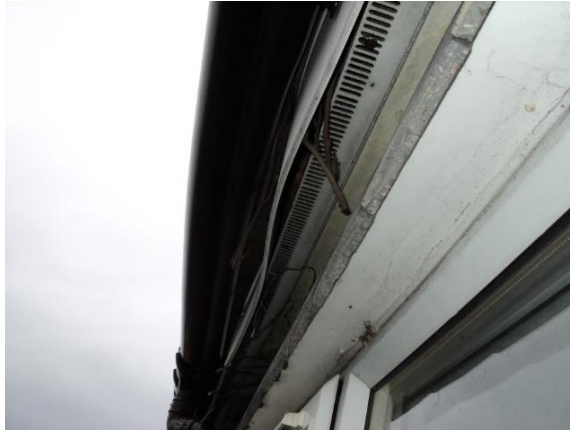
The roof edge timbers are considered to be in a satisfactory condition with no evidence of any significant defect. The Wisteria on the rear of the property has been significantly cut back recently and we noted that this had grown into the roof space of the dormer distorting the fascia. The remaining dead branches should be pulled out of the roof space.

Wisteria branches in fascia

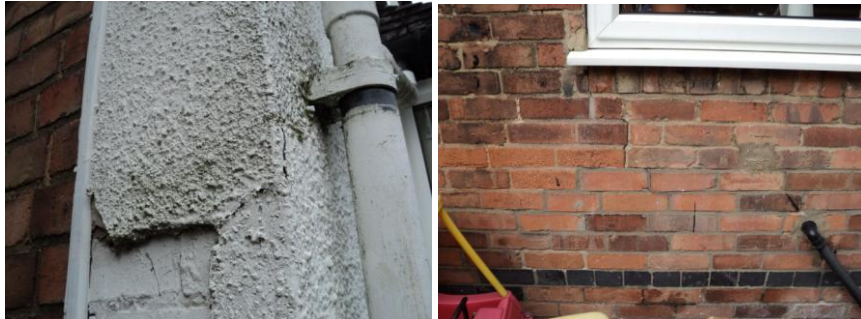
The render (sand and cement coating) to the front elevation of the property

has some unkeyed and blown areas which now require localised hacking off and patch re-rendering. This was particularly noted around the porch opening and to the left side of the front elevation. A quotation should now be obtained from a building contractor for this work. It is difficult to give an estimate of the cost for this type of work as we were not able to access all parts of the render to check its soundness.

Damaged render to front

Crack below kitchen window

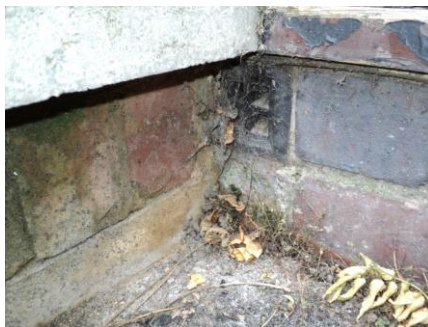
Sub floor ventilation to the living room and dining room requires some improvement. The vent to the rear of the dining room has been obscured by the door step and this should be enlarged. The two sub floor vents to the bay are partially blocked with debris and should be cleared through and a new air brick should be provided to the right side. This should be relatively low cost.

Blocked vent by rear step

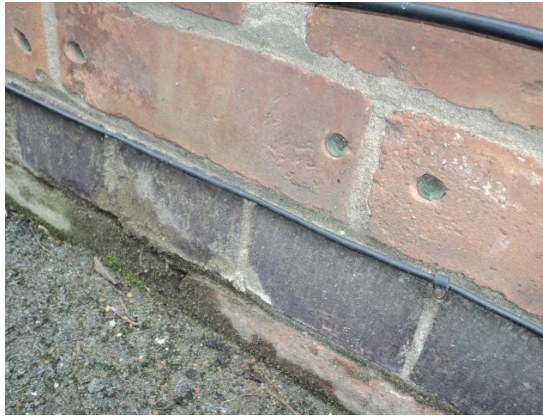
Chemical and blue brick DPC

We did not note any evidence of a problem with rising dampness in this property and consider that the damp proof course is effective. You should try and obtain any guarantees for the DPC installation.

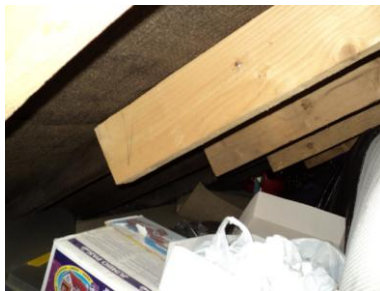
Where visible, the roof timbers appear to be coping with the imposed loading with no evidence of significant distortion or weaknesses. We assume that the loft conversion was undertaken with Building Regulation Approvals having been obtained. There are no obvious signs of defect to this part of the property and the floor appears to be firm and level underfoot indicating correct construction. Additionally the rafters around the loft conversion have been strengthened. Obviously our inspection of the loft is restricted as we have not undertaken any damaging exposure works.

Strengthened rafters to loft

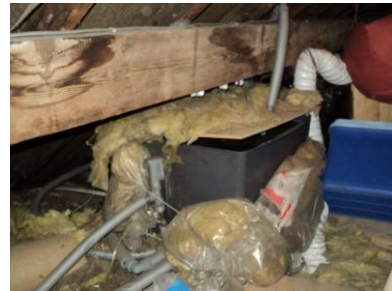
Old stains to rear purlin

We noted some old staining to the purlin in the rear loft space which was dry when tested with a moisture meter. There is no obvious reason for this and this may have pre dated the roof being re-covered.

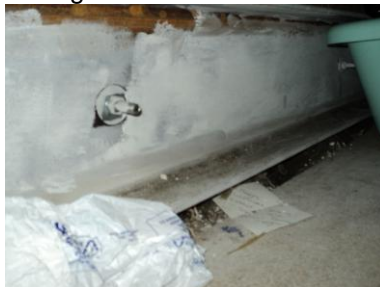
Steel supporting joist to loft

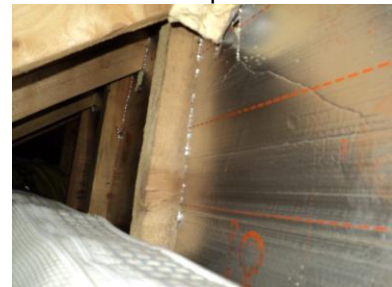
Insulation around loft conversion

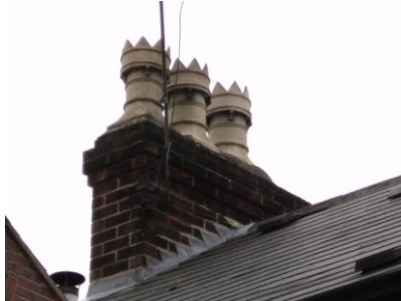
Ventilation is required to redundant flues to prevent an excessive build up of moisture within the chimney flues which can cause external decay to brickwork and internal damp staining. This has occurred to the dining room chimney breast with a large number of spalled/eroded bricks now visible externally on the side of the property. This has occurred as the moisture

Stack removed

laden bricks freeze and the faces being forced off. We recommend that a suitable vent is placed into the front of all sealed fireplaces and the rear flue on the chimney stack is vented at its top. It may be beneficial to also provide a vent half way up each redundant flue on the external wall. This should allow the trapped moisture to naturally reduce. A quotation should now be obtained from a competent bricklayer to cut out and replace the worst brickwork on the left side of the property and to provide vents.

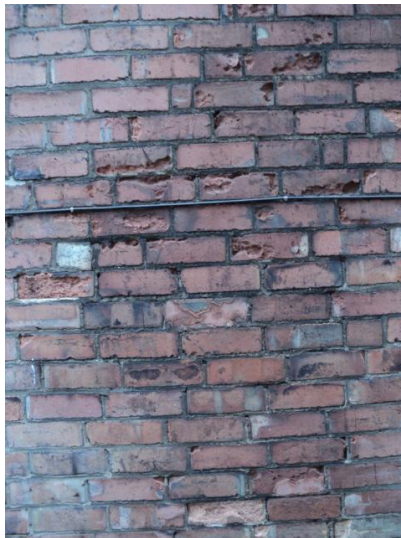
Eroded brickwork to left wall/flue

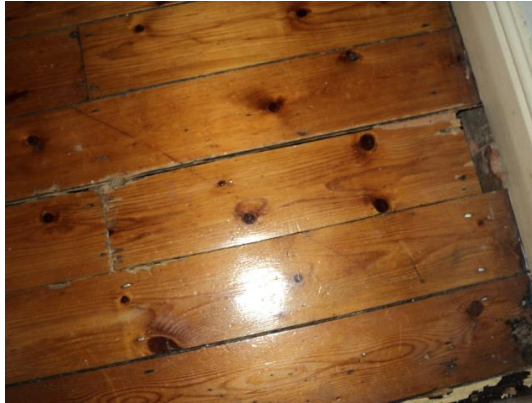
The upper floors are of suspended timber and these are in satisfactory order. There is a damaged floorboard to the rear bedroom but this replacement is not essential.

Damaged floorboard

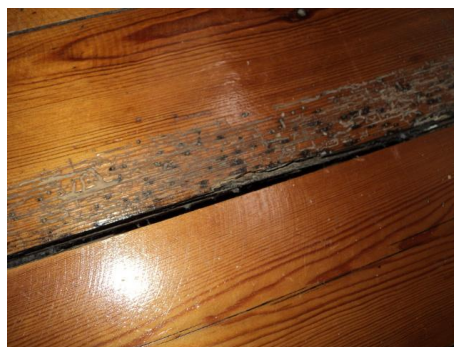
Wood boring beetles lay their eggs in timber which bore out when hatched and this can affect the structural strength of timbers over time. We found no evidence of active woodboring beetle attack to the timbers around the property, however almost certainly in a property of this age, there will be some in hidden floor timbers. There is evidence of old attack to floorboards around the house but nothing to suggest that this is active.

Old worm to the floorboards

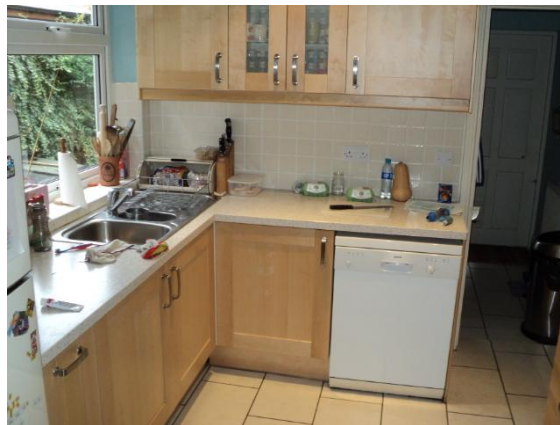
The kitchen is modern and is to a satisfactory standard for the property.

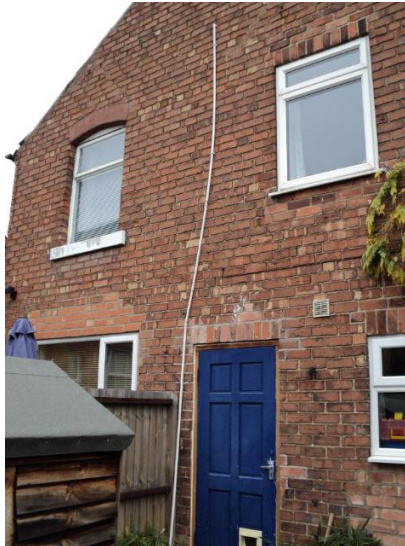
The condensate pipe from the boiler on the rear should be fixed to the wall and straightened.
