56 Example Street  
Nottingham  
NG2 5XY

# Housebuyers Report Plus.

Level 2 Survey

Report ref no: RG35616

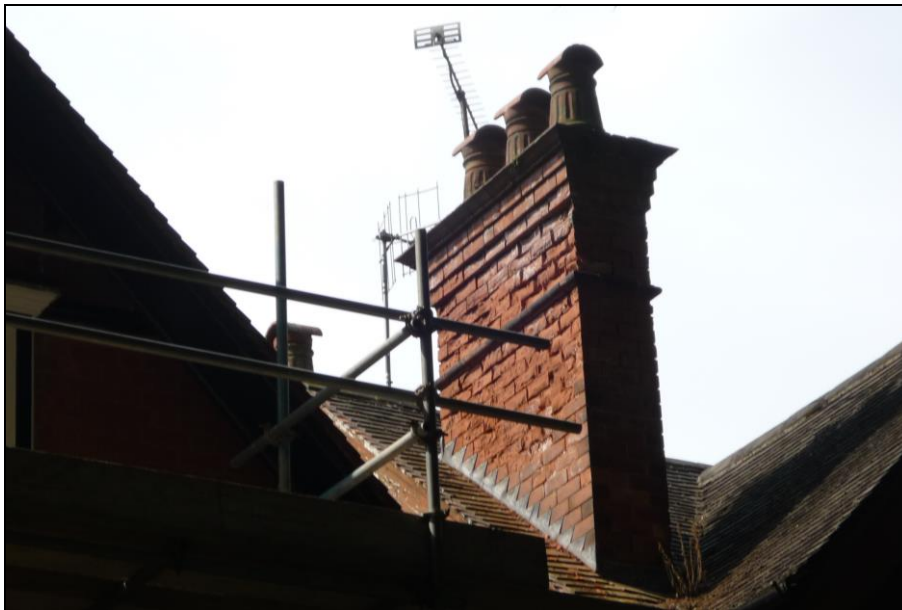
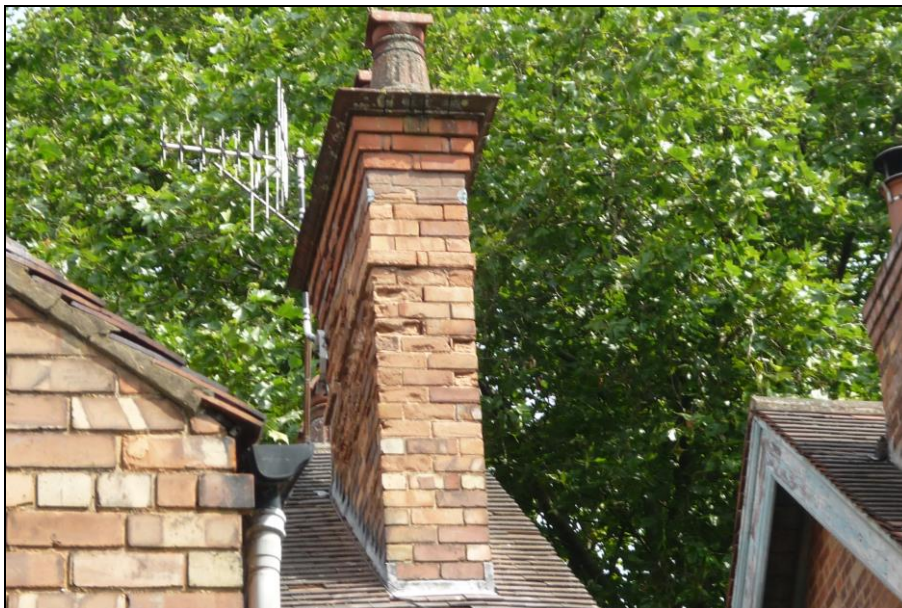
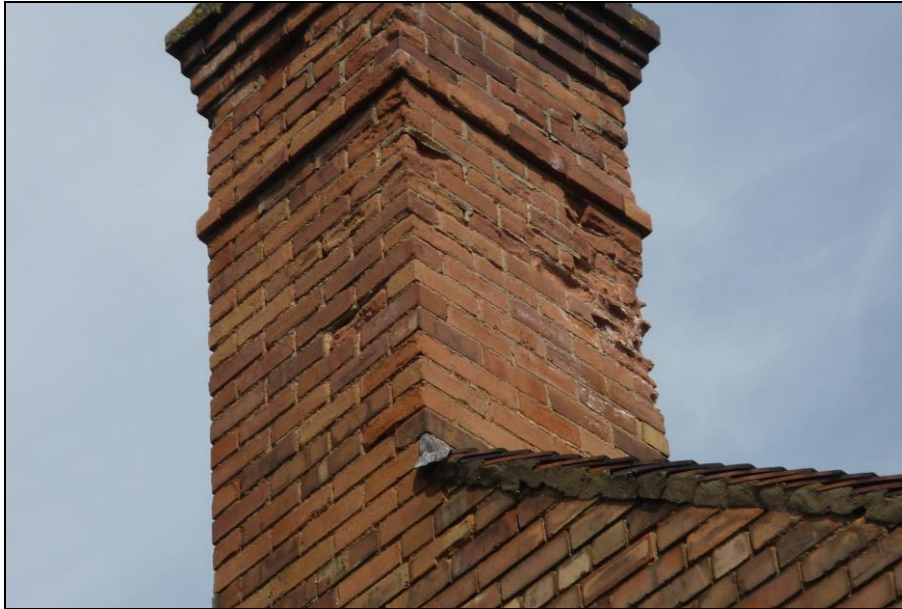
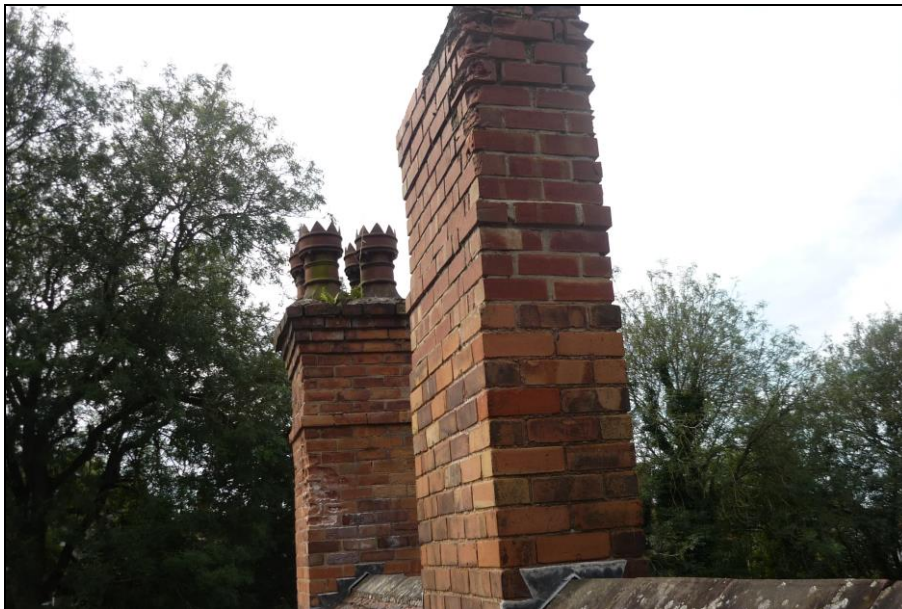
The property has four chimney stacks. The brickwork to the stacks is very heavily eroded and significant repair works or rebuilding of the stacks is likely to be required. We recommend that you obtain a quotation from a roofing contractor for their repair if the stacks are to be retained, before purchase.

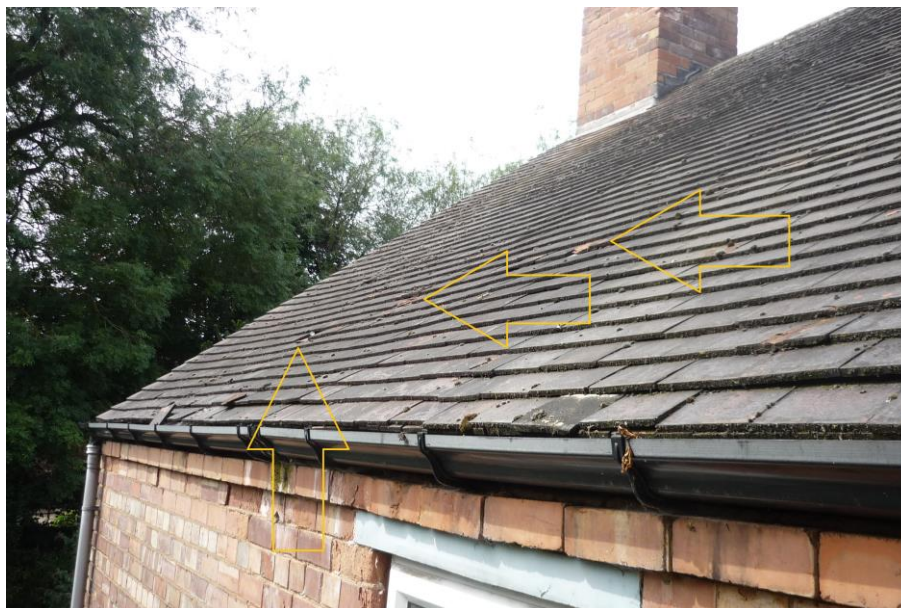
The condition of the roof coverings is considered to be generally satisfactory with no evidence of significant defect or leakage noted. There are a scattering of slipping and broken tiles to both the front and rear roof slopes and a roofing contractor should inspect the roofs and provide a repair quotation.

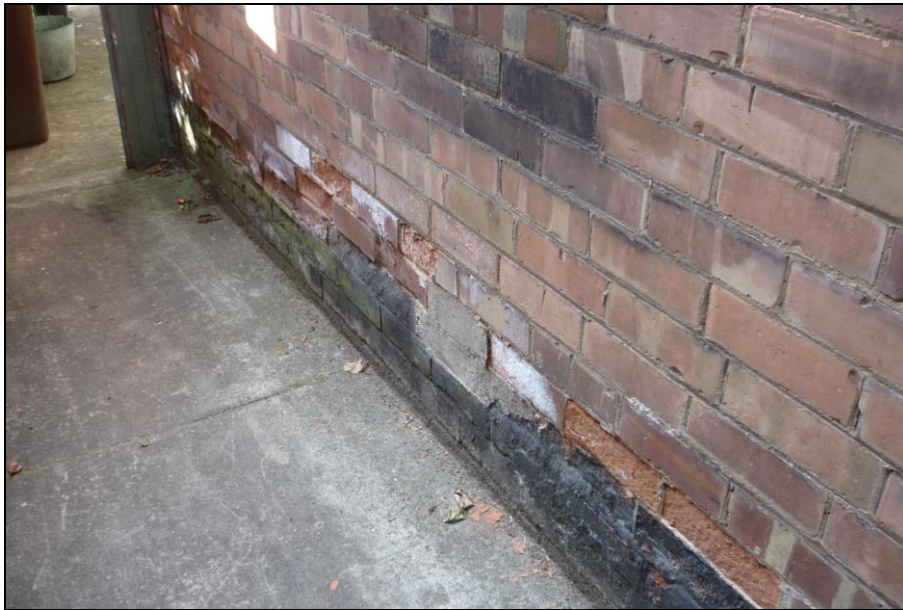
The external walls to the property appear to be of traditional solid brickwork. The walls appeared to be generally satisfactory but there are a large number of frost damaged and eroded bricks to the left side flank wall of the property and a building contractor should provide a quotation for cutting out and replacing the worst affected bricks.

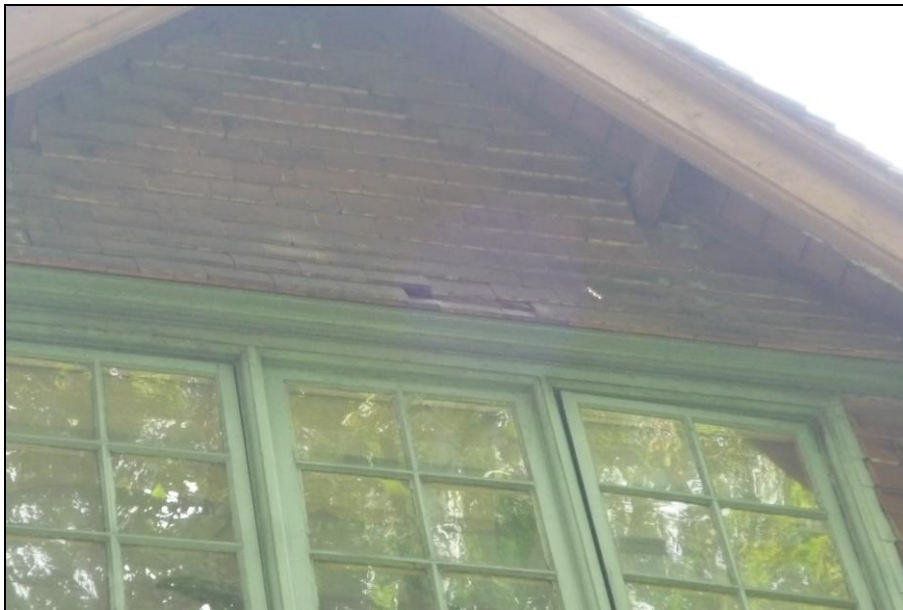
There are some tiles missing on the front wall of the property and these need to be replaced.

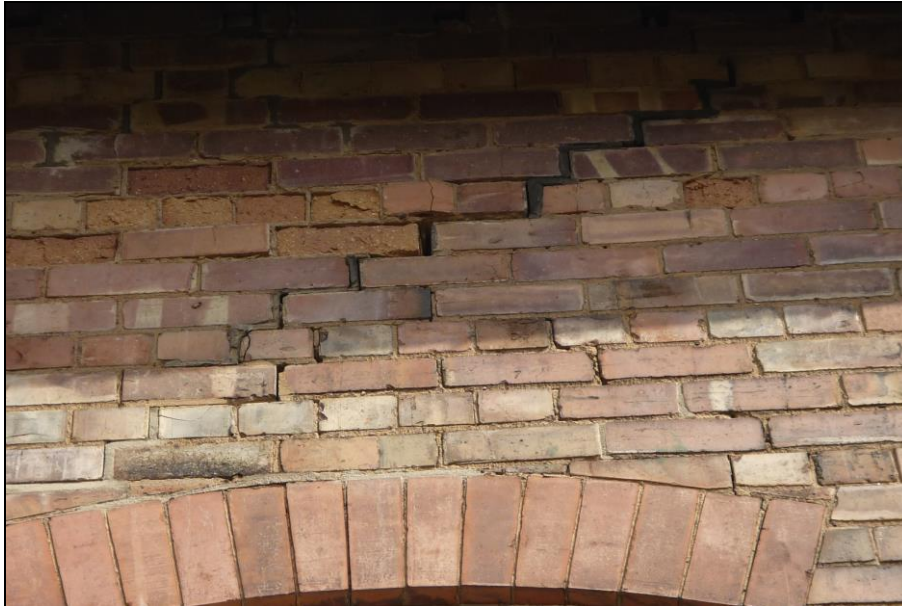
There has been evidence of minor initial settlement type movement with a slight slope of the whole structure to the left side. This is most noticeable to the left side of the front bay window. There is additionally a stepped crack between the rear bedroom window and roof edge. This is typical for this type of property as this is an area of structural weakness. We recommend that the crack repointed including crack stitching bars to prevent reopening.

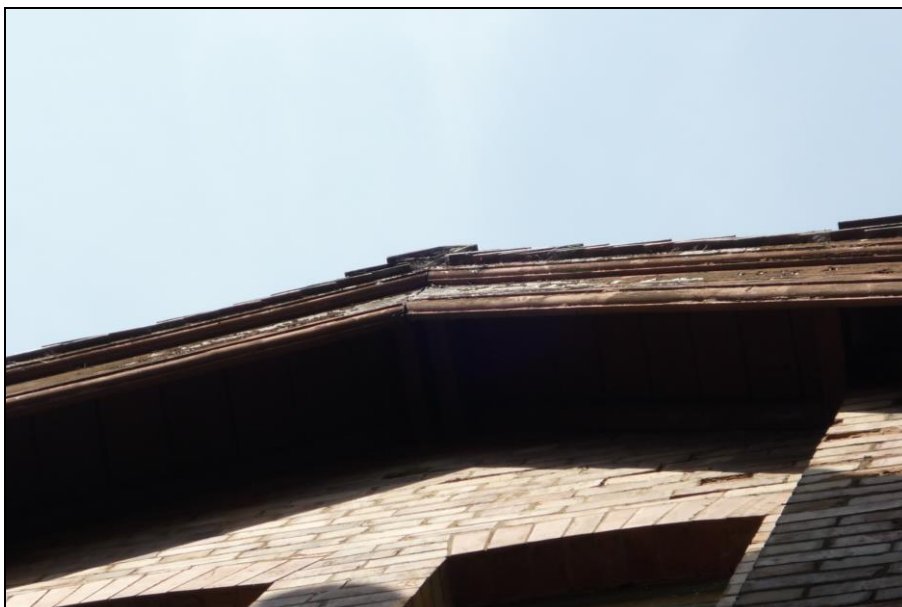
External decorations are in poor condition and redecoration of all external timber areas is now required. You should obtain a quotation for this before purchase as some work is at height and scaffolding is likely to be needed.

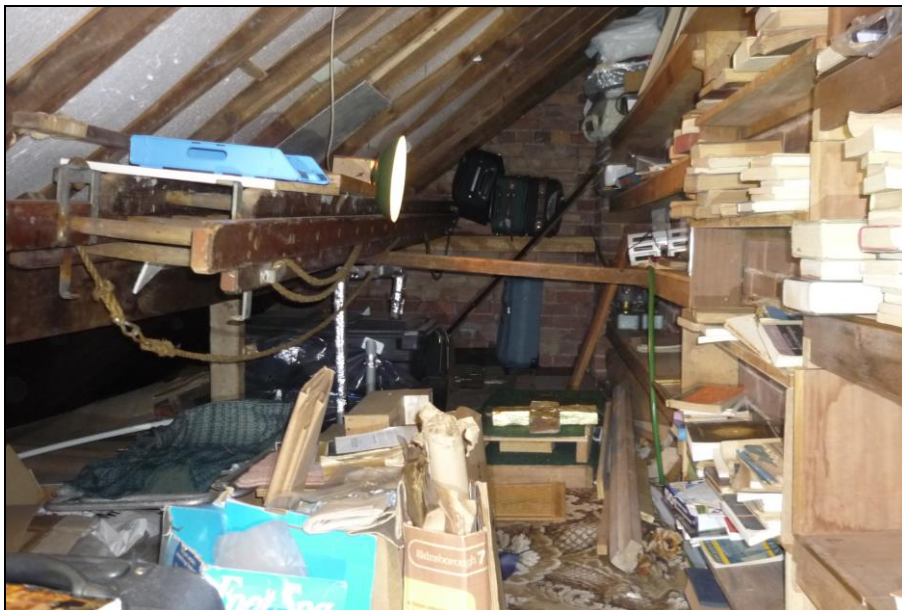
The roof space was accessed via the door in the landing wall. The hatch in the second floor rear bedroom ceiling is screwed into place and has not be opened.

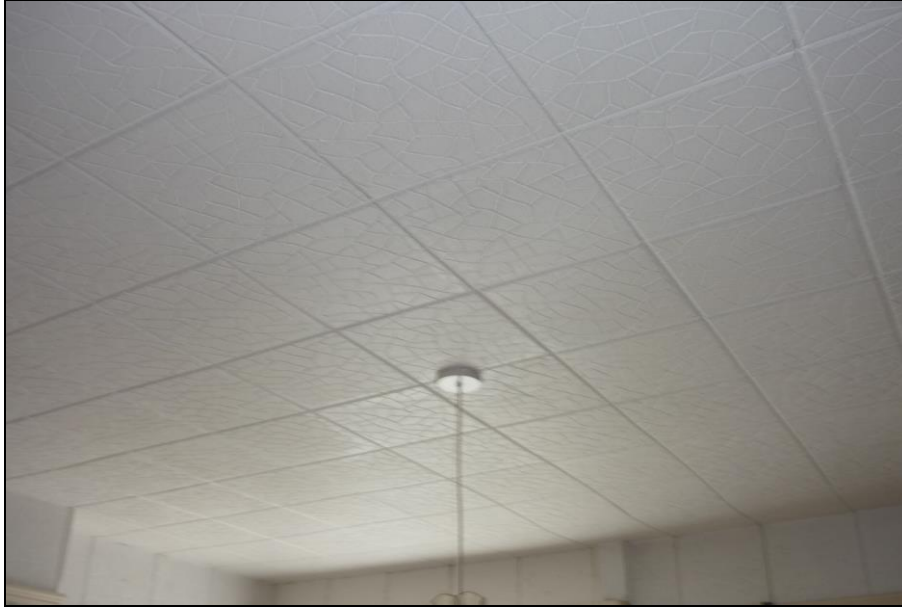
There are a large number of ceilings finished in polystyrene. This should be removed as this is a potential fire hazard. Care should be taken when removing the polystyrene as this could well damage the plaster behind leading to more extensive replastering being required.

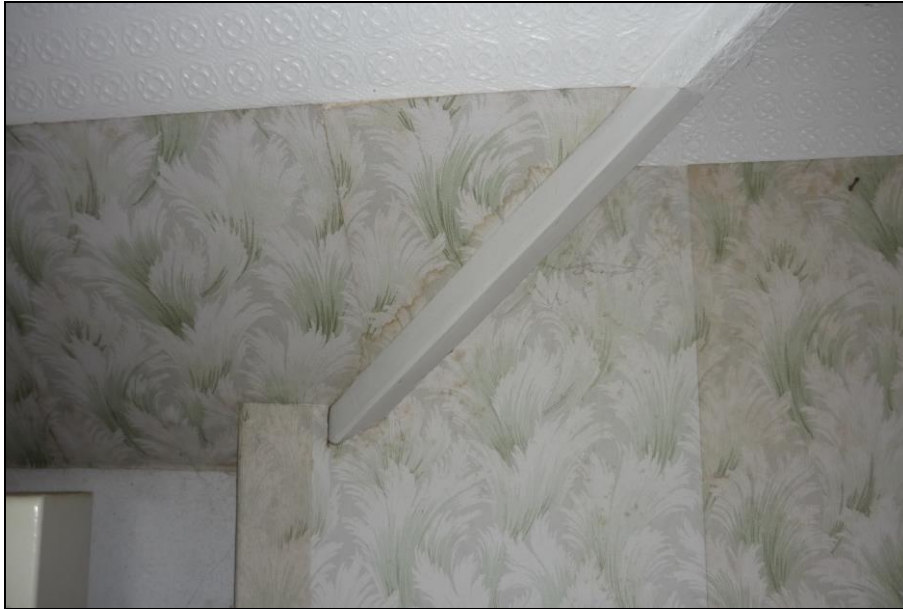
We undertook an inspection for dampness using an electronic moisture meter where we were able to access the walls without moving furniture. We found no evidence of rising dampness in this property. There is some minor penetrating dampness to the second floor front bedroom roof which may be related to a blockage of the left side valley gutter externally.

There is some minor dampness under the valley gutter to the second floor front bedroom. Externally the valley gutter is blocked with debris which could be the cause of the problem. This should now be cleared.

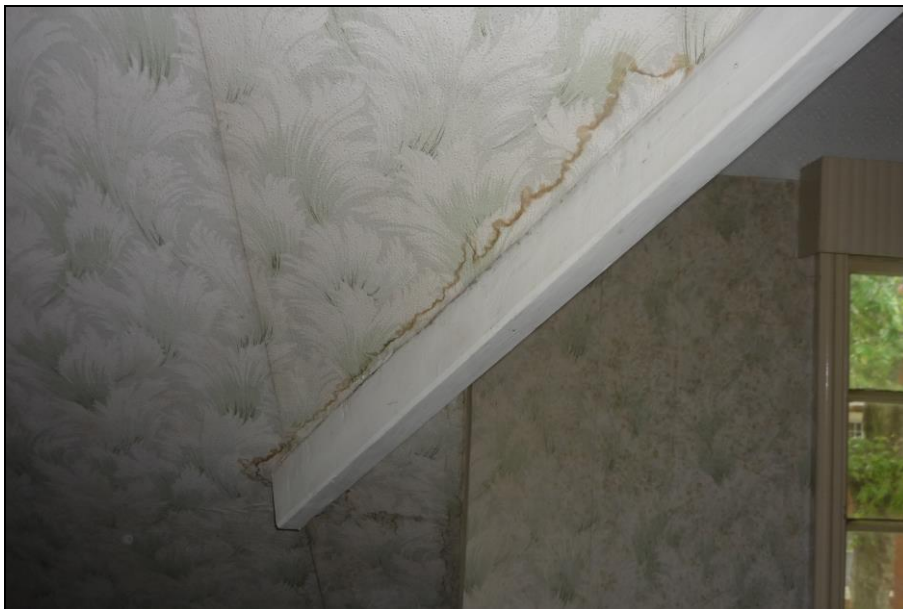
There is similar dry staining beneath the right side valley also.

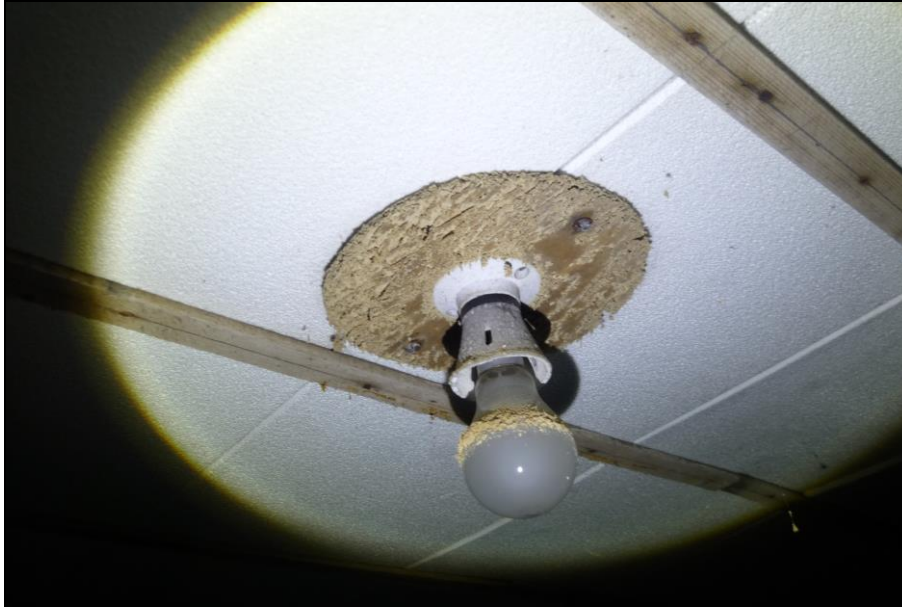
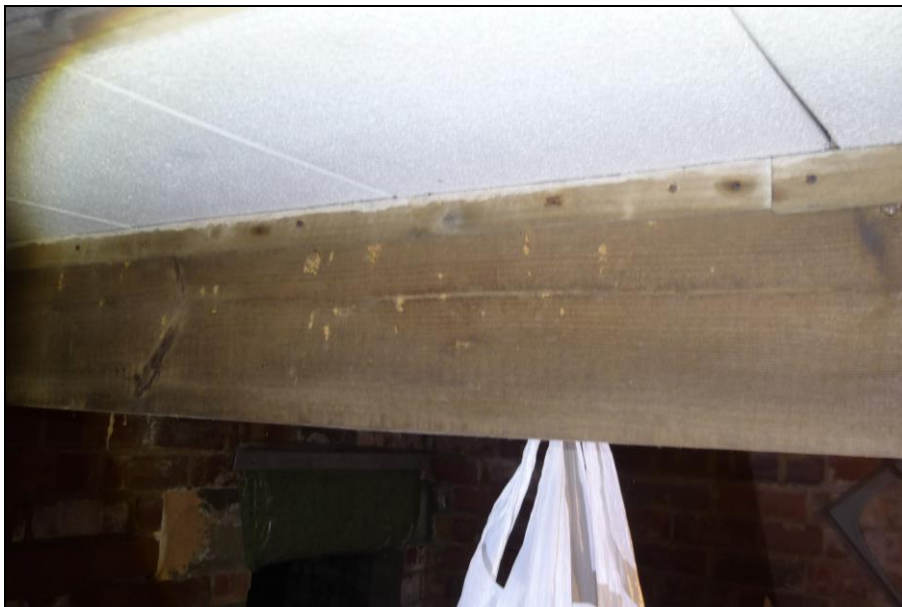
We noted signs of woodworm to the accessible timbers in the cellar. The cellar ceiling is lined preventing an inspection of the flooring above but this is likely to be similarly affected. An inspection should be undertaken by a timber treatment specialist and appropriate remedial work carried out.

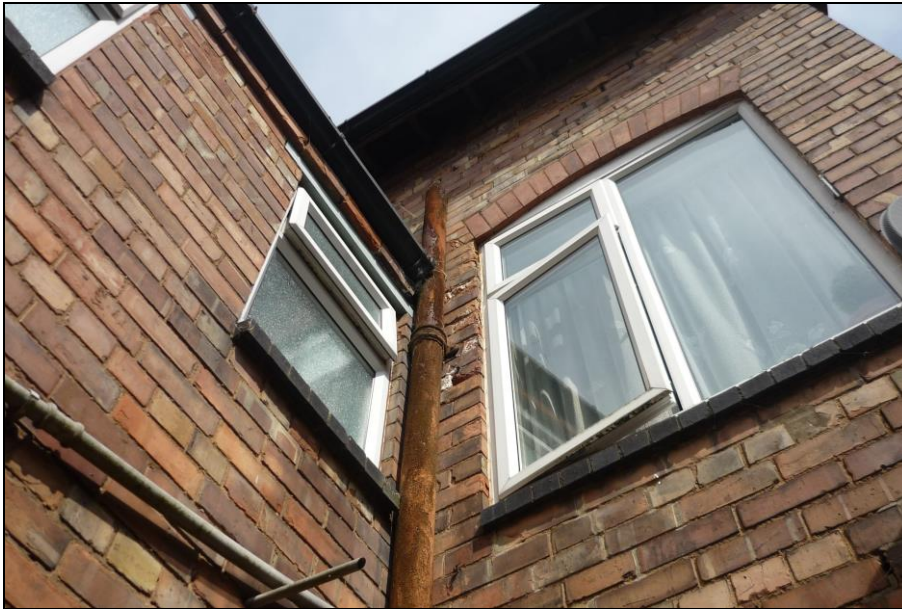
The soil pipe is corroded and is broken at its top. This should now be replaced.

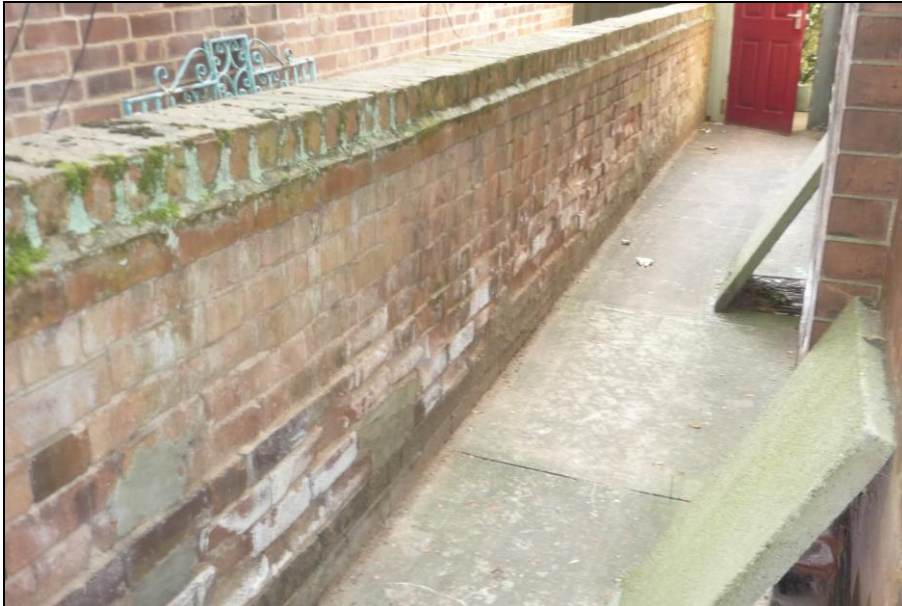
The brick wall to the left of the house needs repairs to eroded bricks.
