**Address of property:**  
28 Example Avenue  
Nottingham  
NG6 3ZZ

**Date of inspection:**  
25<sup>th</sup> February 2025

# LEVEL 3 SURVEY REPORT

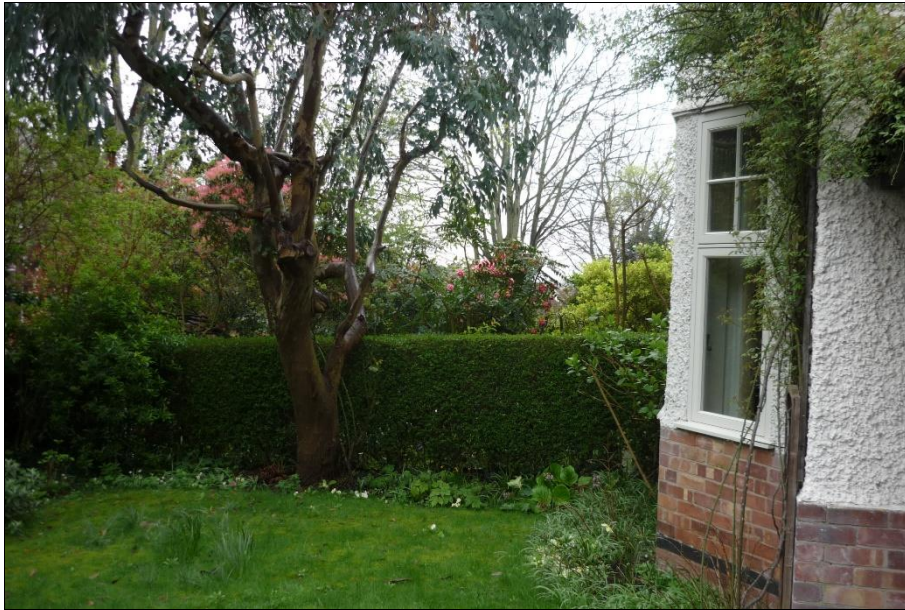
Tree and tree roots can damage a property and drainage systems. There is a Eucalyptus tree in the front garden. These have a very high water demand and can grow rapidly. The soils in this area are often in clay which can dry out and shrink and affect foundations. This tree should be kept at its current size and not allowed to grow larger.

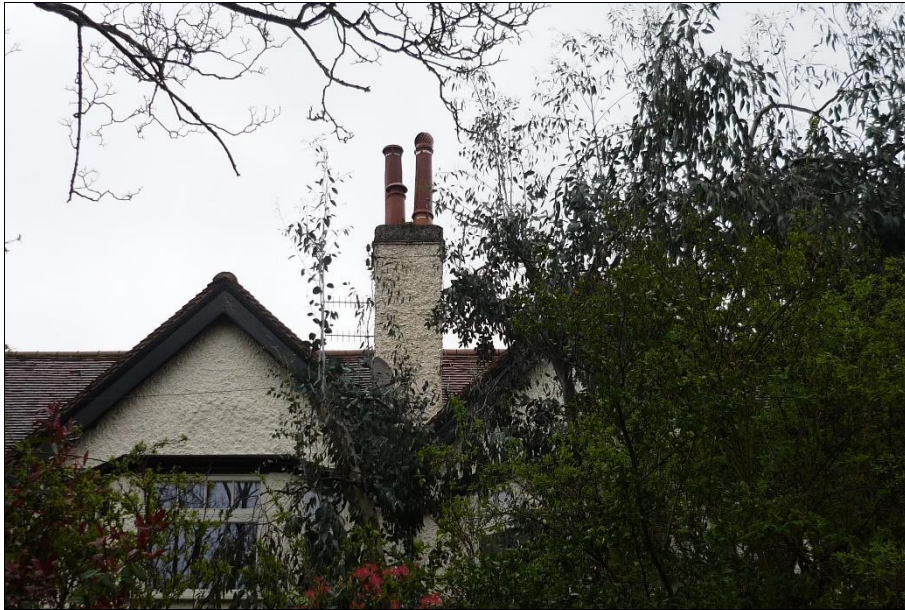
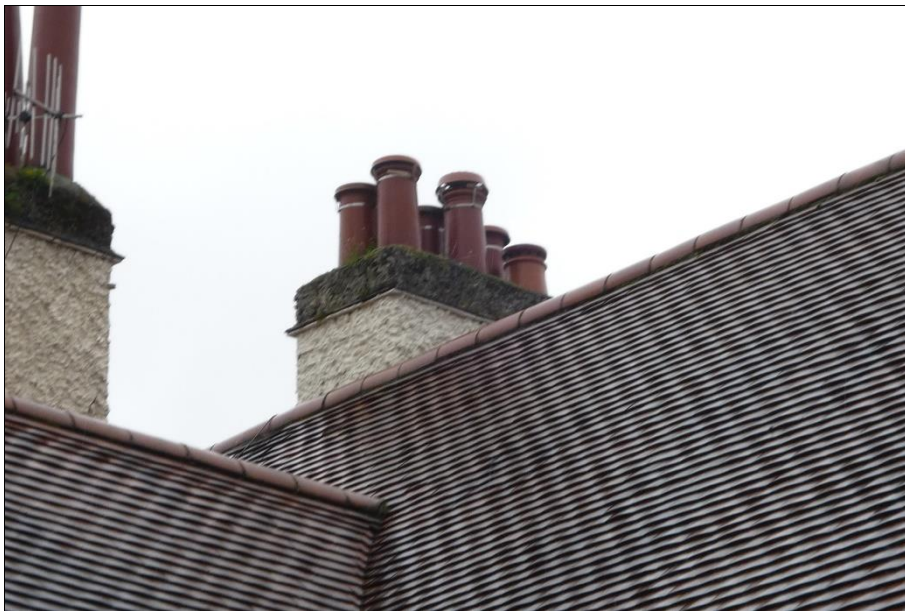
The property has two chimney stacks. The stacks appear to be in generally satisfactory condition with no evidence of significant defect noted. The pots appear to be all be rain capped and vented apart from one to the front stack which has a rotating cowl designed to improve the draw.

The lead flashings are satisfactory with no signs of any internal water penetration. However, lead tends to work loose over time to both chimney and roof flashings due to thermal movement and occasional re-fixing may be needed to minimise the risks of dampness and timber deterioration. Repairs are best undertaken with a flexible sealer, rather than mortar, as it will allow for movement of the lead and will not corrode or stain the metal.

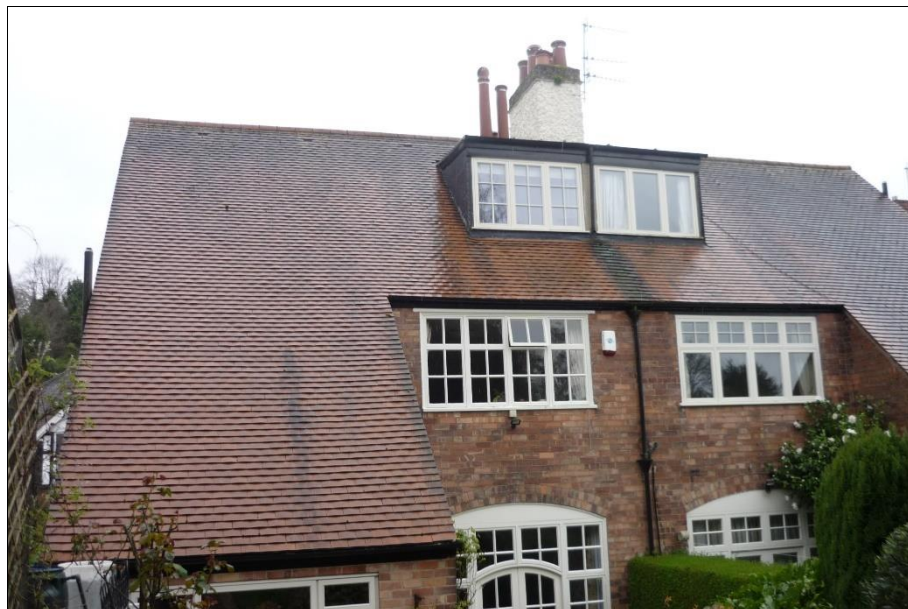
The roof is a pitched (sloping) timber-framed structure, covered with clay tiles laid over a felt underlining. It is understood that the roof was re covered around 2002.

The condition of the roof coverings is considered to be satisfactory with no evidence of significant defect or leakage noted. We cannot inspect the flat roofs over the front bay and rear dormer.

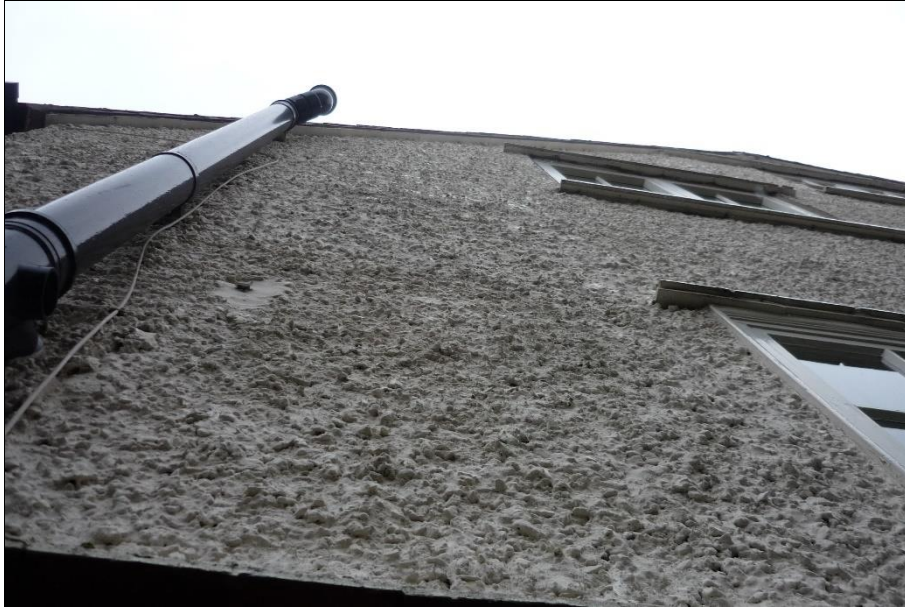
The walls appeared to be generally satisfactory with no evidence of significant structural movement or other defect noted. The render appears to be well bonded with no significant defects noted. There are however some uneven patches to the right side which could indicate that the render has lost its bond. We cannot access these areas to confirm this as they are at height. Occasional checks should be made of the rendering as some future repairs may be required. This is common to this form of finish.

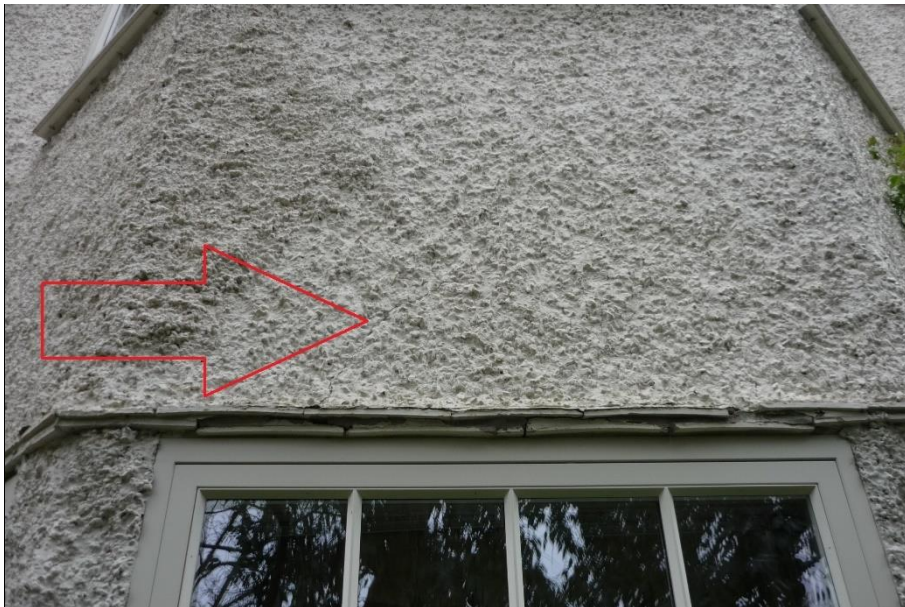
There is a minor crack to the render and to the brickwork under the right side bay window. This is a minor settlement crack where the timber beam over the window has settled slightly but this should not progress further.

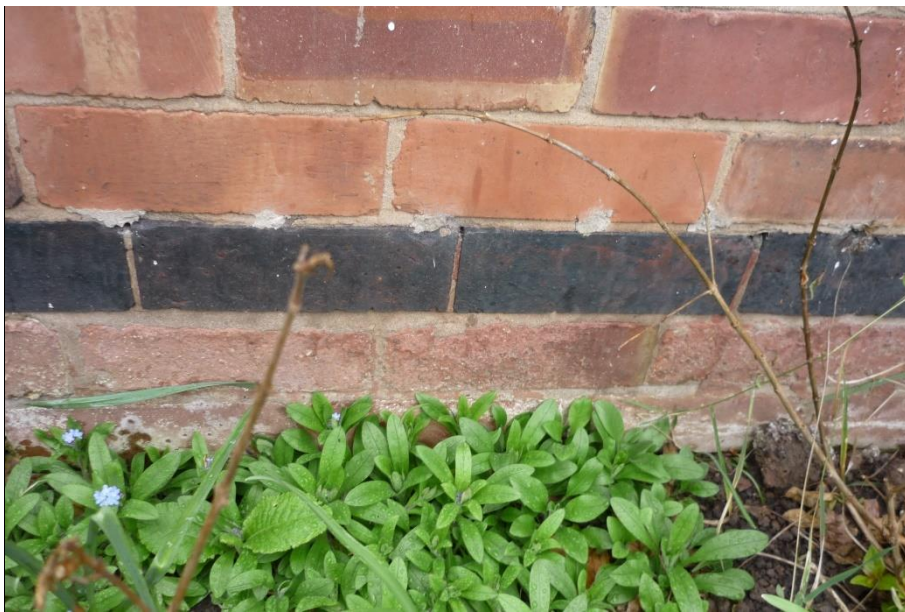
The property appears to have a chemical and engineering brick damp proof course at low level to prevent ground water from rising up the walls.

Walls require a damp-proof course to prevent moisture travelling up through the structure which can lead to internal dampness, perished plaster, spoilt decorations and rot in skirting boards and other timbers. Dampness can penetrate if there is no damp-proof course, or if the damp-proof membrane in the flooring is not properly bonded to the wall damp-proof course at the edges. We conclude that the damp proof course is functional as there was no evidence of rising dampness inside the property. We also found no evidence of penetrating dampness.

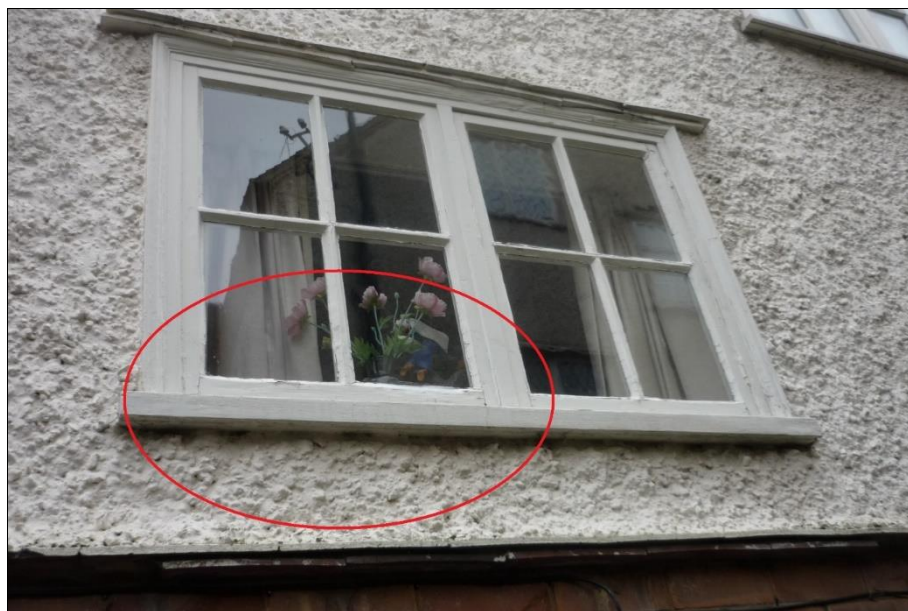
The windows are predominantly considered to be in a generally serviceable condition. The landing window on the right side of the property is however rotten and this will require repair or replacement.

**Condition Rating: 2**

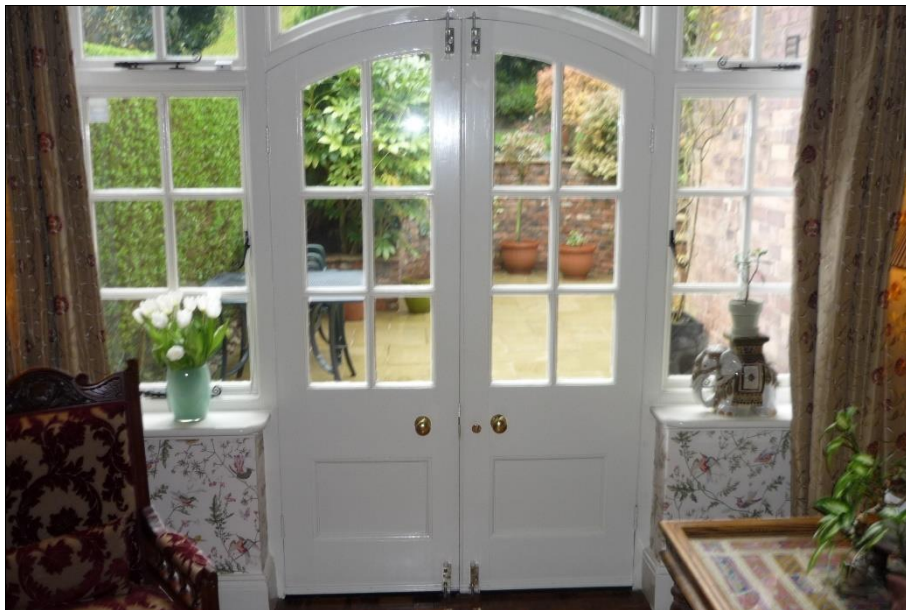
The external doors to the property are of timber construction. These are in satisfactory condition with no significant defects noted. The double doors to the rear living room have not been opened at the request of the owners as these are understood to be difficult to shut in the winter as they swell up. The doors are in reasonable condition but we have not seen these in operation. They may well need some adjusting and draught stripping.

**Condition Rating: 2**

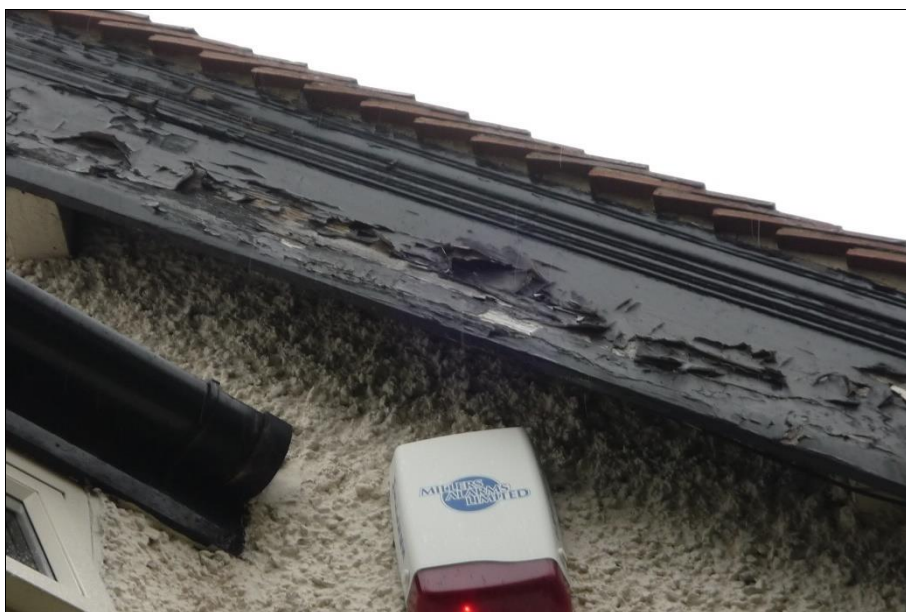
External decorations are poor to the front roof edge joinery (barge boards) and a quotation should be obtained for redecoration. This may entail a scaffold and therefore could be relatively expensive. It is difficult to assess the quality of the timber however there may well be some localised wet rot requiring further repairs found upon closer inspection. Some of the original windows and doors are at the stage where redecoration is also required.

**Condition Rating: 2**

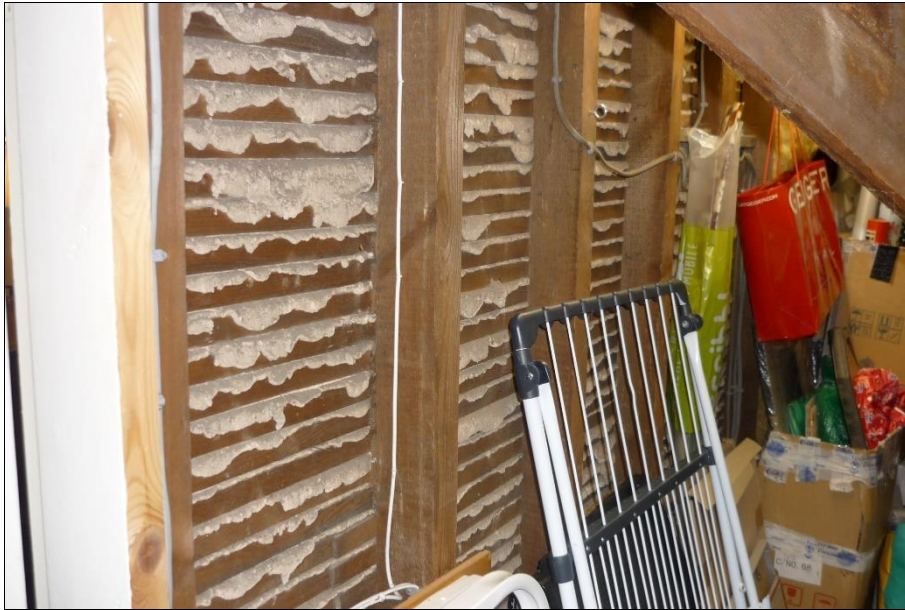
We cannot access the roof space over the second floor bedroom to check the amount of insulation. The vertical walls of the walk in roof space need to be insulated. Wall insulation (internal or external) can be installed but this is very disruptive and costly. The thermal upgrades possible to an old house are limited. If thermal performance is very important to you, you would need to consider a more modern property.

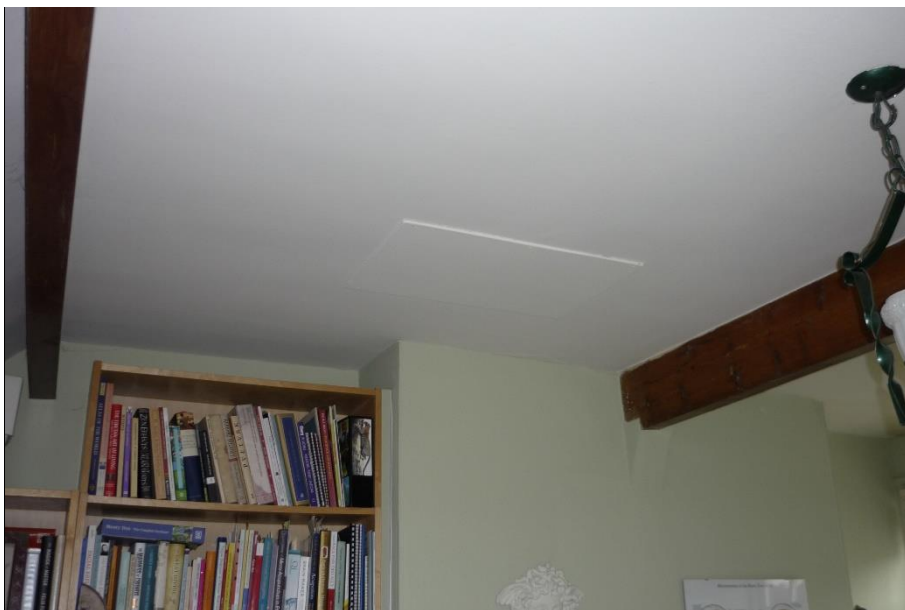
The roof space was accessed via the door in the second floor bedroom wall. There is a hatch in the ceiling over the centre of the left side bedroom however this is screw fixed and painted over and we have not attempted to remove this panel to access this part of the room. We cannot assess the levels of insulation present therefore.

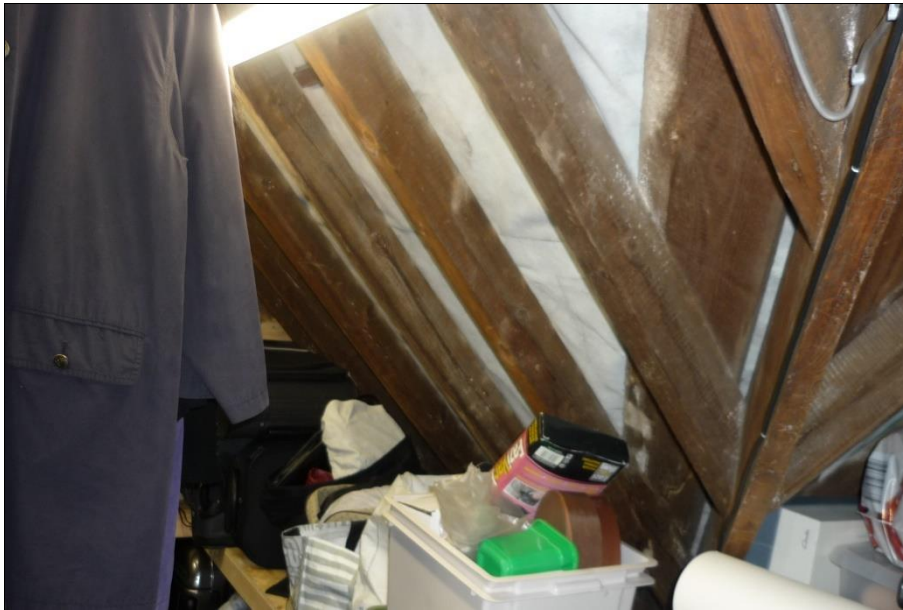
The roof is formed with equally spaced timber rafters supported at mid span by horizontal purlins supported on the external walls. The structure appears to be coping with the loading as there was no evidence of bowing or distortion to indicate any weakness with the roof timbers.

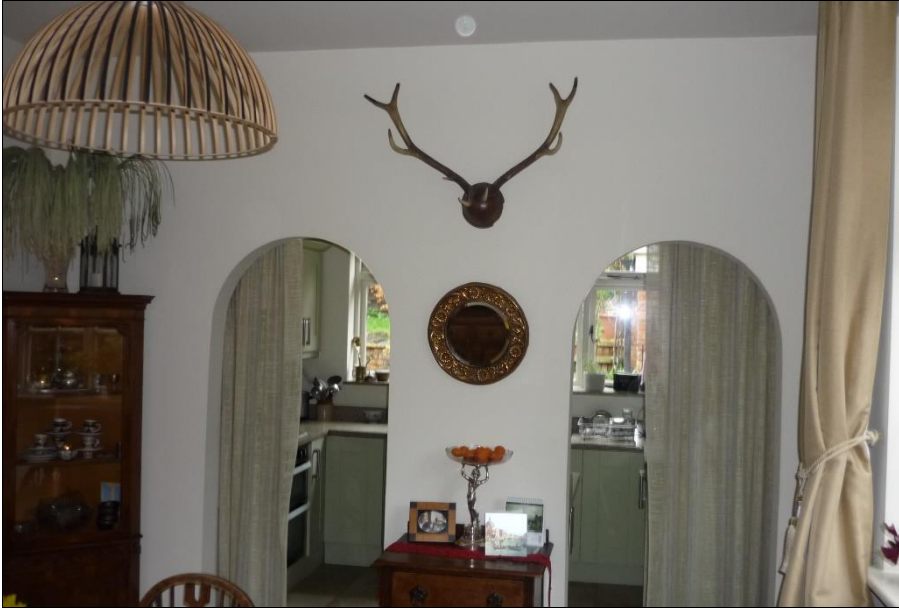
Many buyers would wish to open the kitchen up into the breakfast room by removing the internal wall. This is feasible but would need appropriate support as it is loadbearing. A structural Engineer would be required to specify the beam. Building Regulation Approval would also be required.

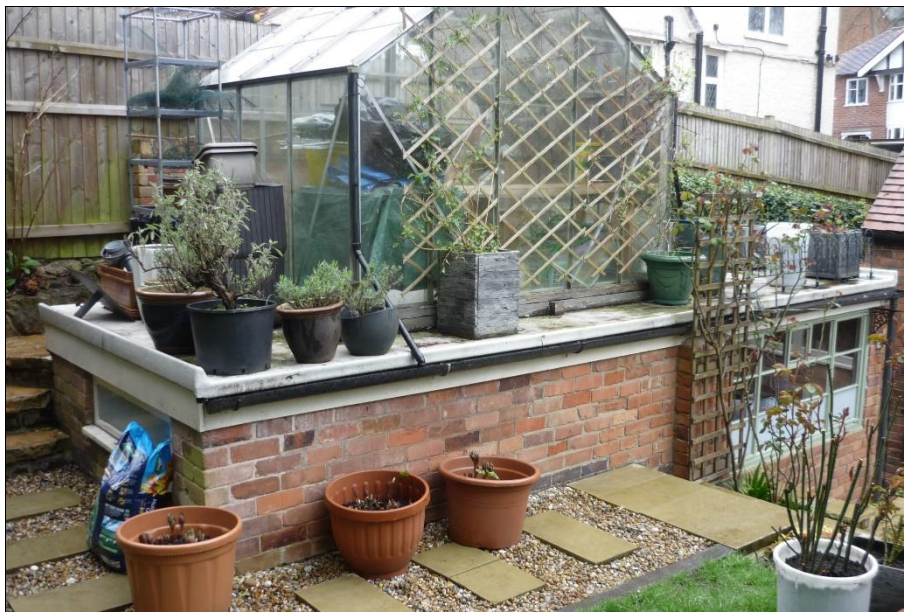
The garage is formed in brick with a fibreglass flat roof over. The garage is in generally satisfactory condition with no evidence of significant defect noted. There are some areas of minor dampness noted to the roof timbers that appear to be drying out, however this could be a result of atmospheric conditions or potentially a minor roof leak. However, this is very difficult to ascertain from looking at the roof surface and this may need to be monitored.

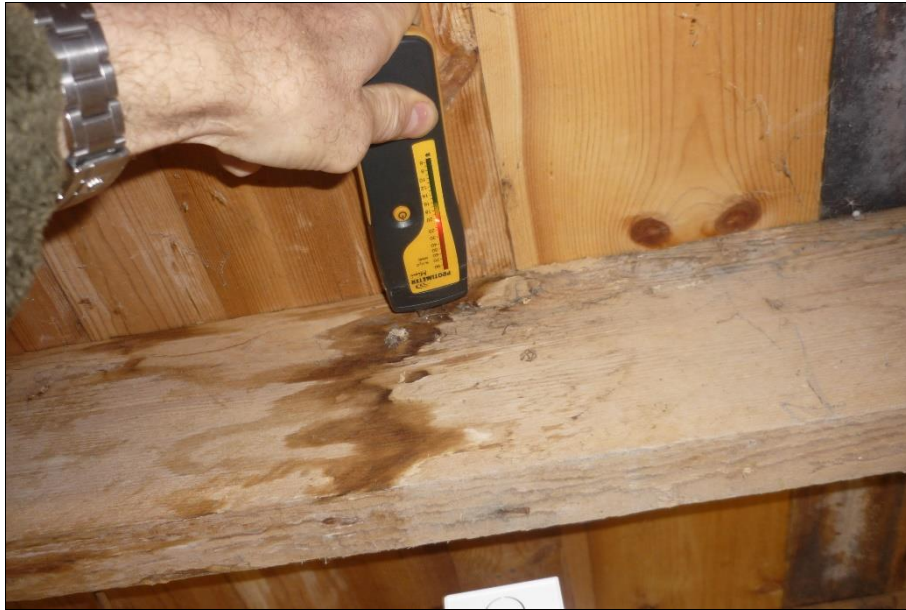
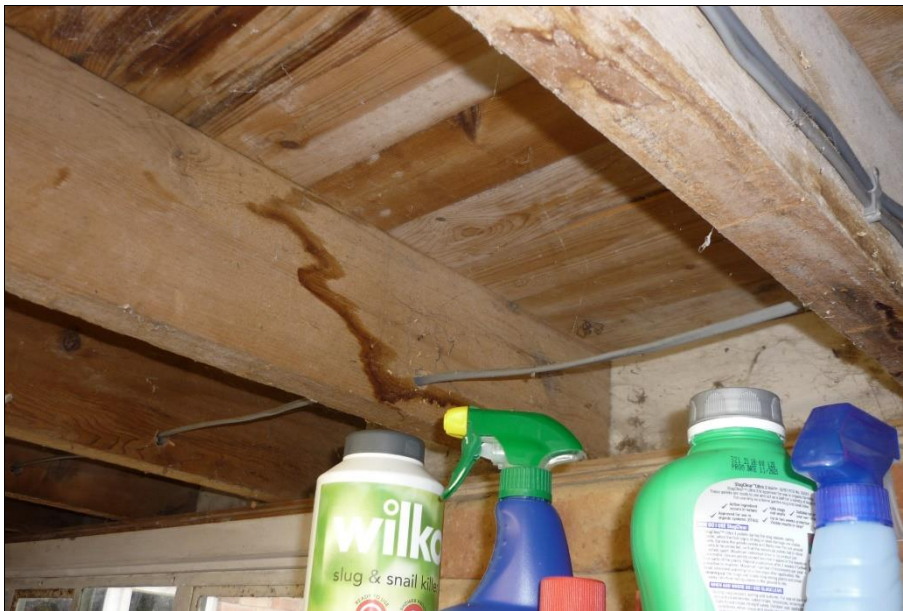
There is a greenhouse and planters on the garage roof. This additional loading is not ideal however there is no sign of stress or deflection of any of the joists. This was in position prior to the current owners occupation. If this is not to be used we recommend that the roof is cleared and not walked on as this could damage the surface.
