**Address of property:**  
28 Example Avenue  
Nottingham  
NG6 3ZZ

**Date of inspection:**  
25<sup>th</sup> February 2025

# LEVEL 3 SURVEY REPORT

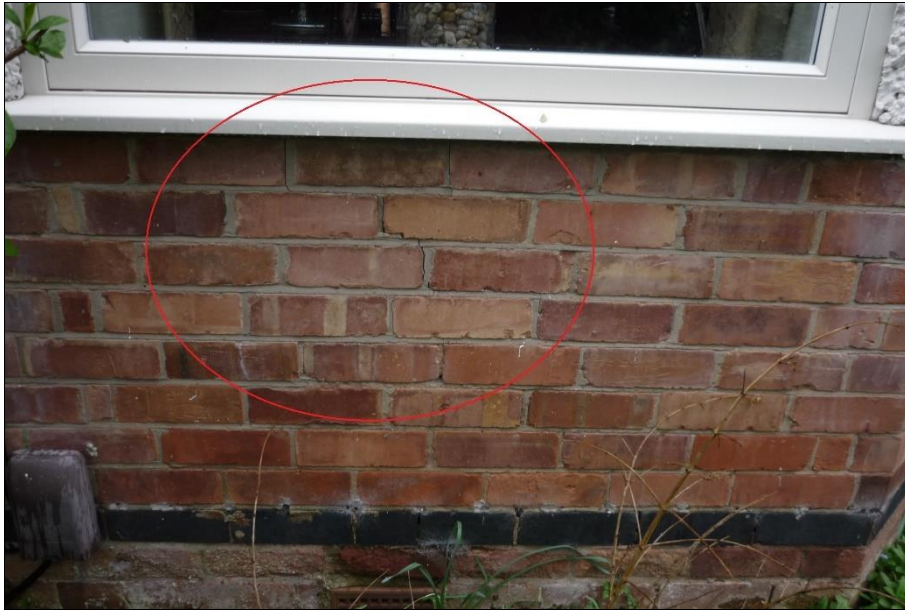
The property appears to have a chemical and engineering brick damp proof course at low level to prevent ground water from rising up the walls.
